Rendering of proposed façade improvements for the Sledge and Barkley Building

I. PURPOSE

IV. B. ARCHITECTURAL ANALYSIS AND EXISTING CONDITIONS

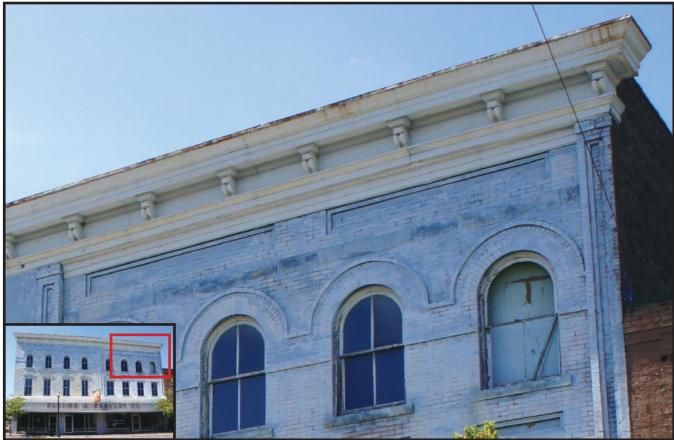
Fig. 17 - Detail of cornice and windows showing the rusting cornice, paint deterioration, and windows with frame damage and missing panes

disintegration. Some of the sashes are sagging inward. It is noted that only a few windowpanes are entirely missing; those that are have been appropriately boarded up. Rusting at the cornice is evident, apparently from metal capping on the top (Fig. 17).

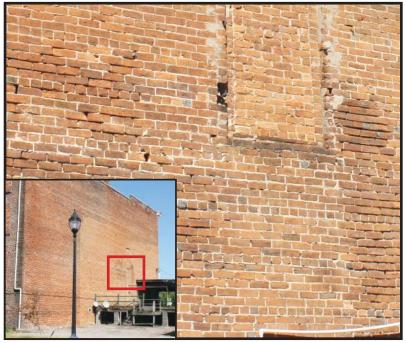
Large areas of mortar disintegration are visible; there is also evidence of brick beginning to sag or disintegrate (Fig. 20). The sagging and disintegration are worse on either side of the infilled doorway, but it is unknown what has caused this level of deterioration at these two specific areas. Other areas of notable deterioration are along the

Fig. 20 - Detail of missing mortar and brick damage

roofline and also along the southwest corner. These areas have seen the most significant water infiltration which most likely has led to the deterioration. There have been numerous repointing campaigns, especially near the roofline. The composition of the replacement mortar is undocumented. Extensive areas of brick and mortar cracking are evident. At the corner of the east façade and south elevation, there is a visible line where the south elevation brick

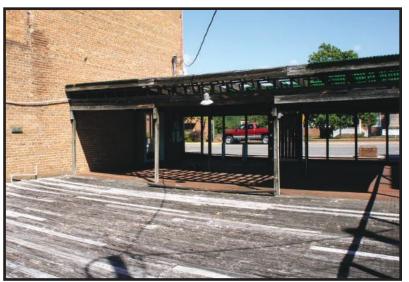
Fig. 21 - South deck showing weathering

heavily trafficked areas. Some of the roofing material is missing and some of the wood posts are bowing. The welded wire fencing is rusted and sagging.

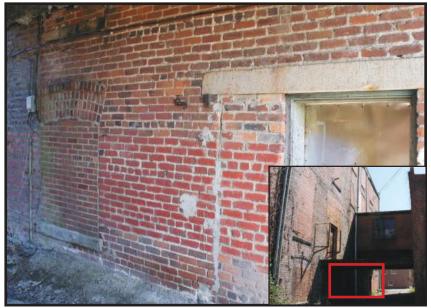
The western elevation is in generally poor condition. The brick is in a similar state of deterioration as the south elevation and there have been poor repointing campaigns with large areas of modern brick replacing the historic brick. Mortar repointing has been performed with a mixture of different mortars, noticeably concrete near the basement and 1st level (Fig. 24). Despite these repointing efforts, there is still a significant amount of brick and mortar erosion, especially near the southern downspout, around the hyphen, and along the basement level. All windows that have been infilled with brick were not toothed in (meaning there is a straight line still present from the original opening), making it feasible and desirable to reinstate missing windows (Fig. 25). The three steel pedestrian doors that are extant

Fig. 24 - Detail of numerous repointing campagins

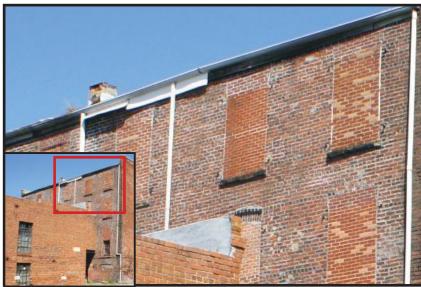
Fig. 25 - Detail of window infill and gutter damage

appear to be improperly connected to the gutter. Staining from rain and biological growth is present on the brick behind and around the downspouts. The downspouts do not have appropriate extensions and therefore deposit water directly at the base of the building. Two of the downspouts direct water onto the hyphen roof where it pools and

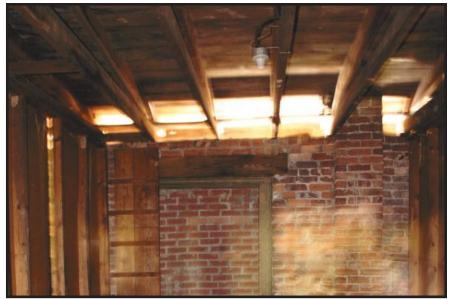
infiltration. This assumption should be confirmed with a detailed inspection. There is biological growth prevalent on wood beams and joists at the roof structure and 3rd floor ceiling, indicating water infiltration. While this does not appear to be significant, further inspection is necessary to fully assess the damage and

Fig. 27 - 3rd floor interior detail of roof beams/joists with sunlight showing through at the roof/wall junction at the cetnral rear of building

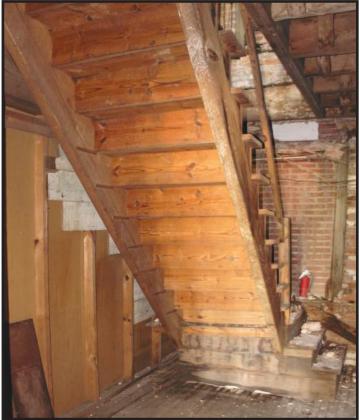
Fig. 33 - 2nd floor stair leading to the 3rd floor

and subsequent first step down are in very poor condition due to water infiltration. It is unsafe to walk on a majority of the landing where the wood has become soft from rot. The riser supporting the top tread? has been replaced with a fresh plank of wood that is also starting to deteriorate. Significant repair and restoration are needed in this area, and are related to deterioration noted in the ceiling above (discussed separately in the "Floors and Ceilings" section.)

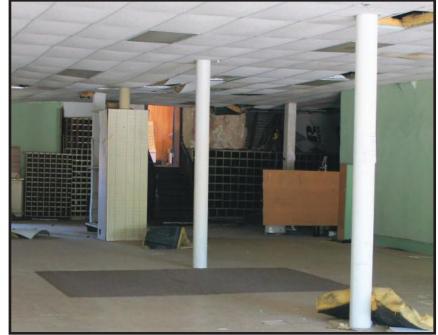
Column designs vary from floor to floor. The 1st floor columns are decorative cast-iron circular columns with a cast-iron capital (presently, the capitals are concealed above a dropped ceiling). The 1st floor columns are in fair to poor condition, with some rusting from water infiltration. Because of the dropped ceiling, a full assessment of the capitals could not be performed at

Fig. 38 - 1st floor columns on northern side

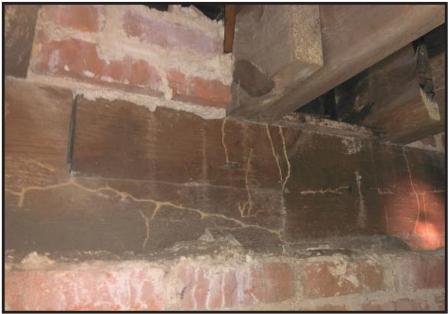
Fig. 41 -Basement ceiling joists showing termite damage

steps lower than the rest of the basement. Large beams cross diagonally under the floor joists near the rear of the building for what appears to be addition support in this back area. In the structural report, it is noted that heavy insect infestation (termites) is present and damage is extensive in the basement (Fig. 41). There is also water infiltration and damage to the floor joists of the ceiling.

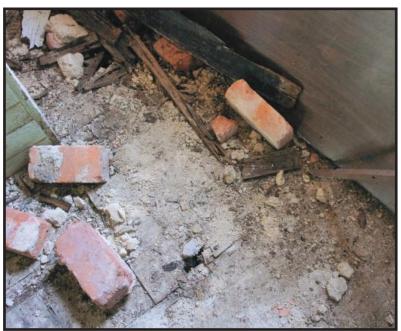
chipped or missing tile, staining and general wear. In the southwest corner, water infiltration has completely detached the tiles from the floor and the wood plank subfloor is exposed (Fig. 42). The entire 1st floor has approximately 11 tall ceilings with pressed metal tiles that are concealed by a dropped ceiling. In the north side of the building in the front room, a plywood painted ceiling is constructed abutting to the drop ceiling

Fig. 42 - 1st floor southwest corner floor damage

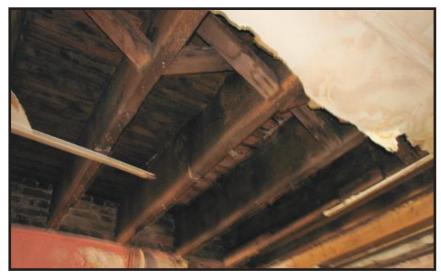
poor condition showing signs of deterioration throughout. There is also significant water damage near the southwest corner of the building (Fig. 44). There are portions of the ceiling which are completely missing, revealing the floor joists supporting the 3rd floor.

Fig. 44 - 2nd floor ceiling damage at southwest corner

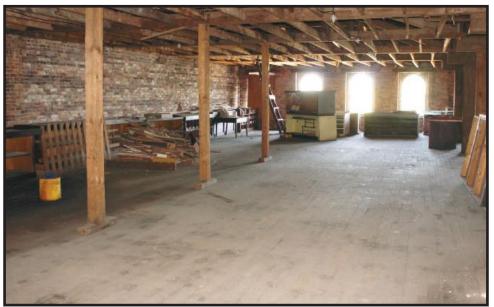
Fig. 45 - 3rd floor showing hardwood and exposed ceilings

The 3rd floor has stained wood plank flooring that runs throughout the space (Fig. 45). The ceiling is open to the roof with untreated joists and rafters exposed. The floor is in fair condition with some areas of rotted material wood and also areas where the wood has been gouged out significantly. Like the rest of the floors, the southwest corner is the worst area in the 3rd floor as well. Rotted floors have made the corner room unsafe to walk over, but the rest of the floors are stable and sturdy. There is

significant weather damage happening along the west wall where the rafters meet the brick at the ceiling. Because the area is exposed to the exterior, it is experiencing more water infiltration and weathering. Mold is present on the rafters and joists and there are water stains also.

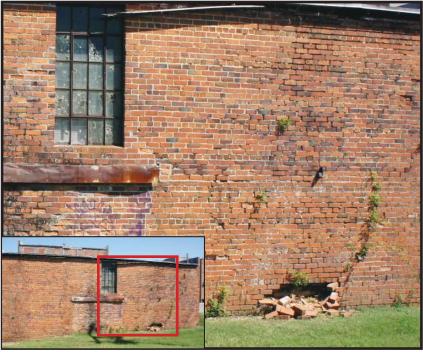
and bridge connect to the building. Biological and vegetative growth is also present, most drastically along the north elevation. Rust stains are evident below each anchor plate. A small portion of the bottom west wall has completely failed and the bricks are laying in a pile on the ground, creating a hole in the elevation (Fig. 53). Above this hole is the most significant mortar deterioration of the building. From

Fig. 53 - S&B Warehouse west elevation brick deterioration

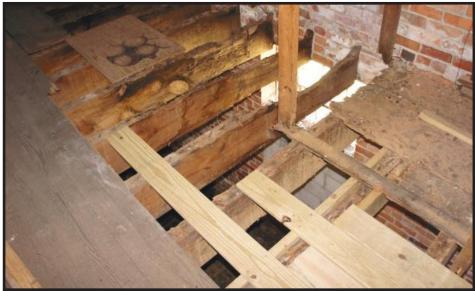
Fig. 56 - S&B Warehouse 2nd floor missing floorboards

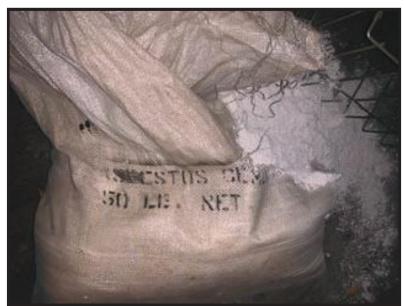
Asbestos was located in the building in the form of two bags of asbestos cement (Fig. 57). The report can be found in Appendix B of this report.

Fig. 57 - One of the asbestos bags found in the S&B Warehouse

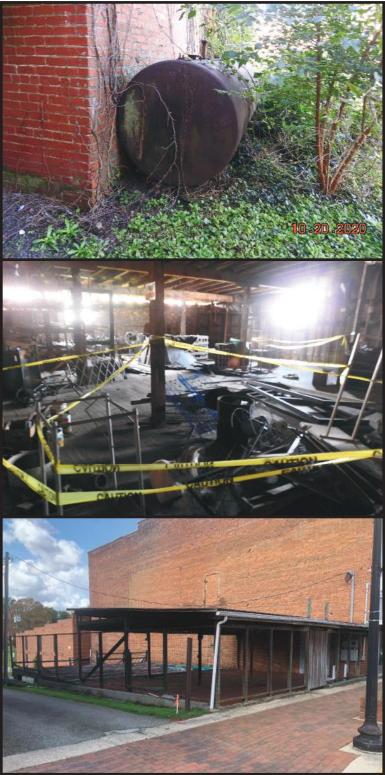
Brownfield remediation concerns (from top to bottom): one of the oil tanks near the rear of the property that need to be removed; an area of the S&B Warehouse that has a bag of asbestos cement present; the exterior deck at the south elevation has pressure treated lumber that must be removed for safety conerns.

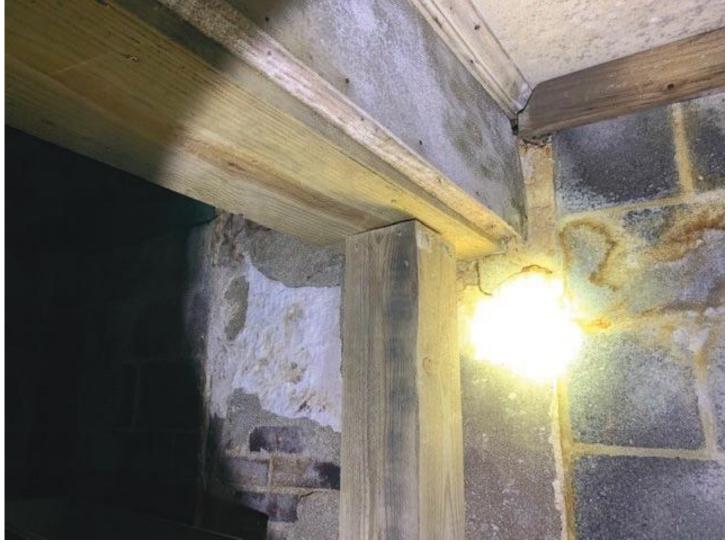
PHOTOGRAPH #24 S&B BUILDING -ADDED 6"x6" WOOD COLUMN – BADLY DAMAGED END OF GIRDER

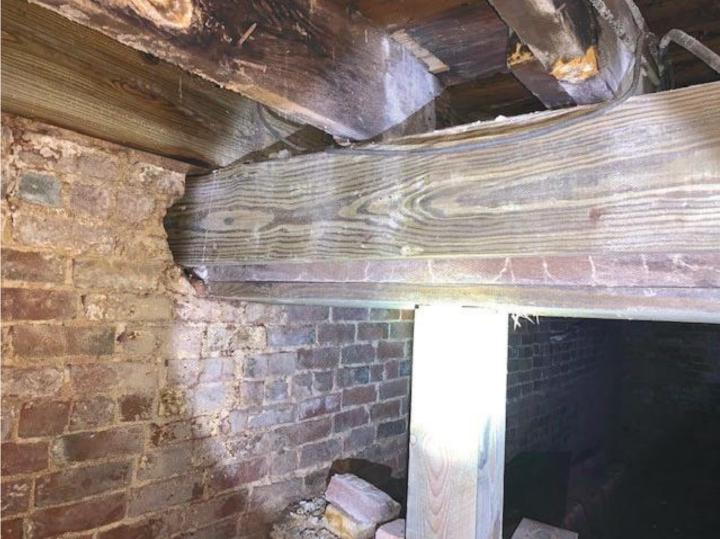
PHOTOGRAPH #25 S&B BUILDING -GIRDER LINE WITH LOTS OF TERMITE TRAILS IN THE LAST 20FT

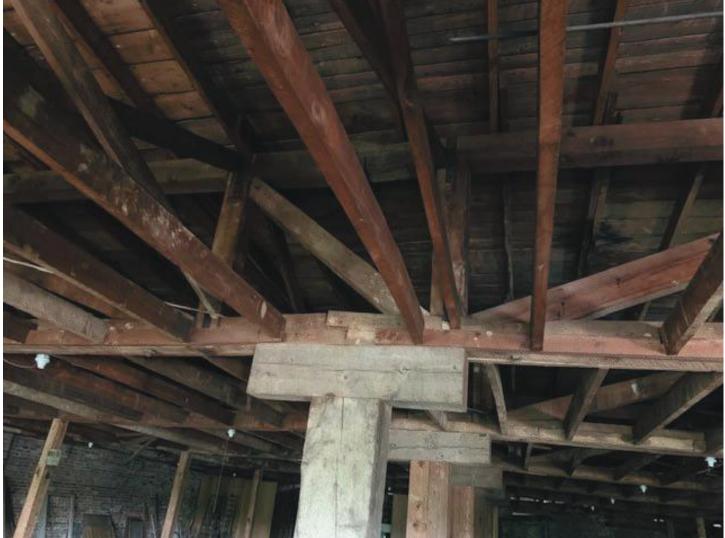
PHOTOGRAPH #47 S&B BUILDING -DETERIORATED ROOF IN SOUTHWEST CORNER

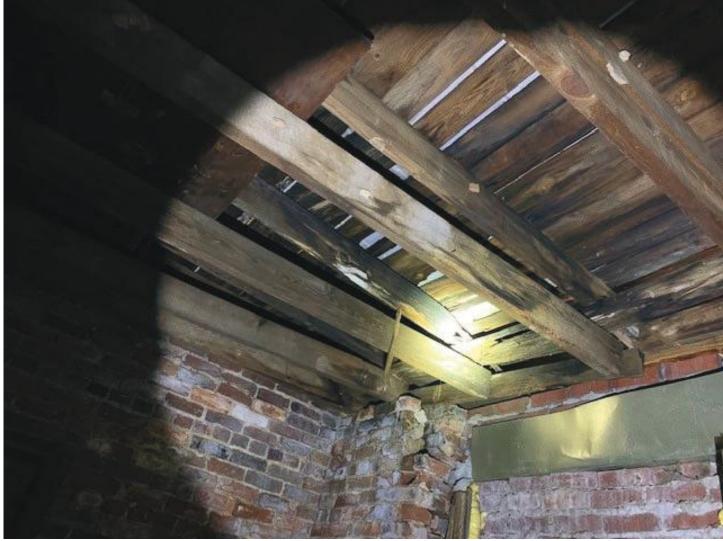
PHOTOGRAPH #48 S&B BUILDING -DETERIORATED HEADER AT ROOF

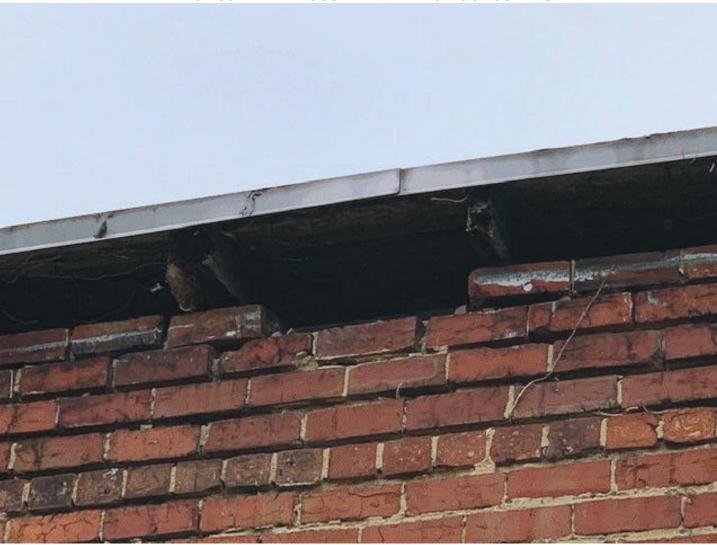
PHOTOGRAPH #54 S&B WAREHOUSE -DETERIORATED LINTEL AND BRICK OVER WINDOW

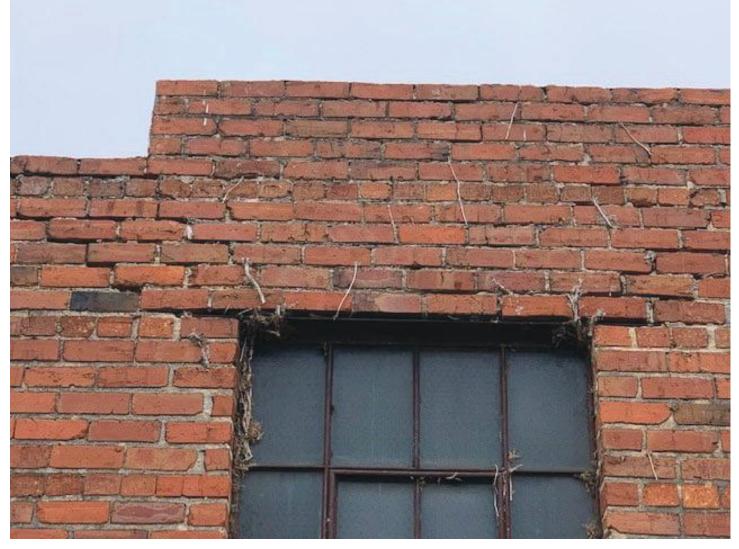
PHOTOGRAPH #55 S&B WAREHOUSE -REAR WALL WITH DETERIORATED BRICK

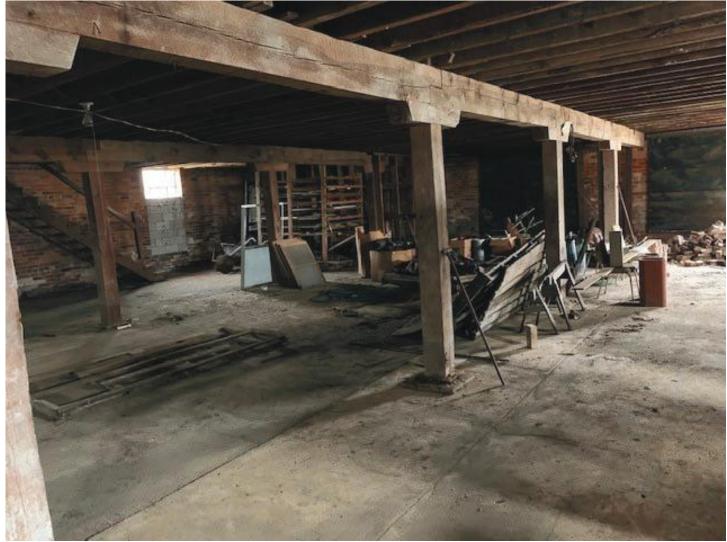
PHOTOGRAPH #57 S&B WAREHOUSE -DETERIORATED BASE OF COLUMN

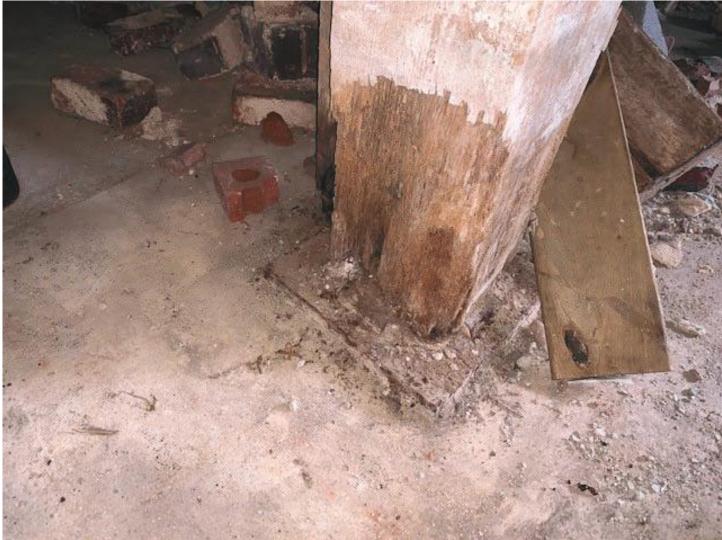
PHOTOGRAPH #58 S&B WAREHOUSE -BREAKING APART BRICK BASE UNDER COLUMN

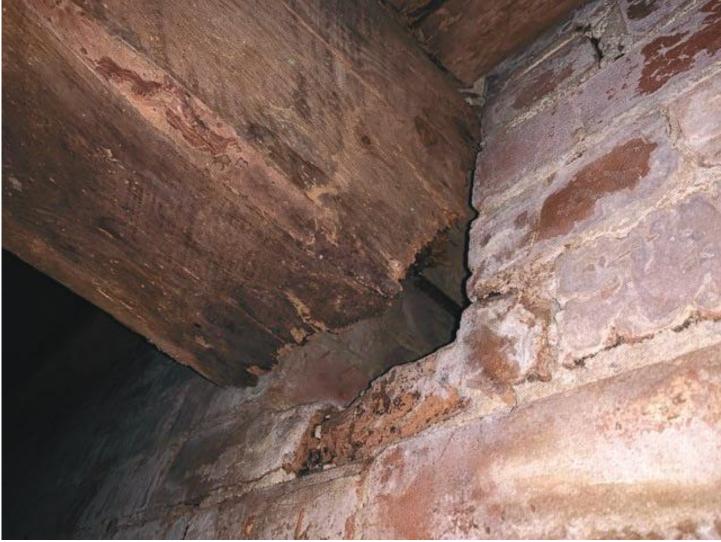
PHOTOGRAPH #60 S&B WAREHOUSE – BADLY DETERIORATED FIRST FLOOR GIRDER

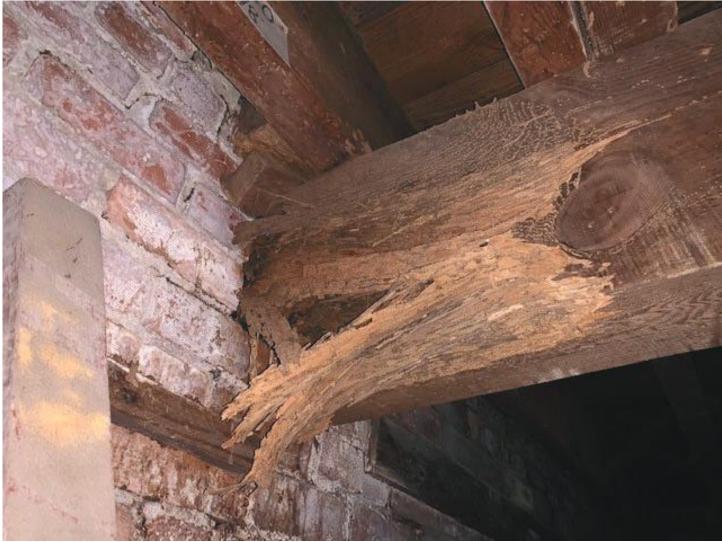
PHOTOGRAPH #61 S&B WAREHOUSE – DETERIORATED FRAMING IN NORTHWEST CORNER OF ROOF
