Rendering of proposed façade improvements for the Sledge and Barkley Building

I. PURPOSE

IV. B. ARCHITECTURAL ANALYSIS AND EXISTING CONDITIONS

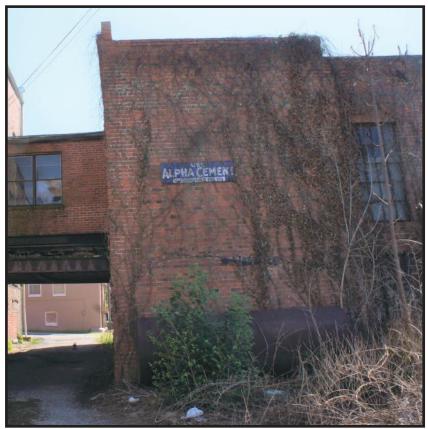
the elevated enclosed walkway between the two buildings. This alley connects the city parking lot to a gravel drive behind the commercial buildings north of the S&B Building ending at Church Street (Fig. 6). Surrounding the S&B Warehouse is a grass yard that abuts adjacent lots. Most of the site is overgrown and the driveway and alley need maintenance and regrading. There is an above-ground storage tank situated on the north side of the S&B Warehouse that requires removal (Fig. 7).

Fig. 7 - Above ground storage tank

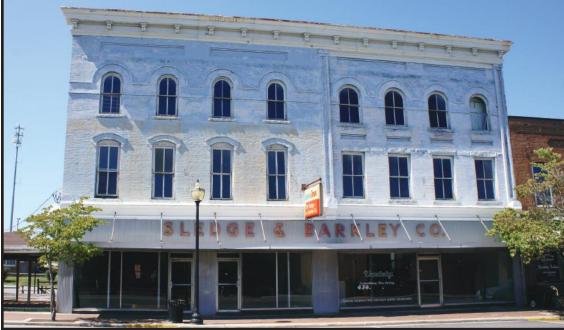
13). Historically, it had three recessed entries; the storefront and entries were replaced between 1956 and 1958 and are now in the same plane as the rest of the façade. The first bay at the left has a pair of glass storefront windows with a thin metal frame and an approximately 6-inch concrete sill at the bottom. To the right of this are two metal-framed storefront doors with a transom above each, separated by a corrugated metal-covered pier. To the right of the doors is a similar pair of aluminum frame storefront windows. The north three bays at the right consist of storefront glass windows flanking a metal storefront door with transom. These are separated from the south (left) bays by a corrugated metal covered brick pier. The storefront windows and doors are in good condition with minor repairs and cleaning needed.

Fig. 13 - East elevation (façade)

While the brick of the façade appears to be in good condition, the rest of the façade materials are in fair to poor condition and the brick does warrant closer inspection. Much of the paint has faded and stained, and there is noticeable water damage in areas. The wood window frames show damage and deterioration including chipped paint and resulting wood rot that has advanced to the point of

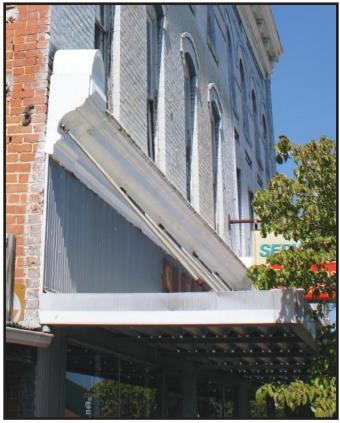
Fig. 14 - Metal awning attached to historic cornice

corrugated metal. Photographs document that the sign dates to the 1950s. A modern flat-roof metal awning was installed between the metalcovered transom and storefront, producing a notable separation between the retail storefront and the upper portion of the building (Fig. 14). This visual separation creates a disjointed appearance which does not reflect the historic era. The awning has been attached to the building at the storefront cornice (and thus obscures a historic feature); it is supported with multiple ridged poles and is in good condition. Photo documentation establishes that the awning was installed after 1980, and therefore is non-historic and non-character defining (Fig. 15). The historic storefront cornice is simple with corbels at each corner and near the middle. The upper floor windows are two-over-two double-hung wood sash with stone sills. A deep cornice with small brackets spaced evenly across the building caps the façade.

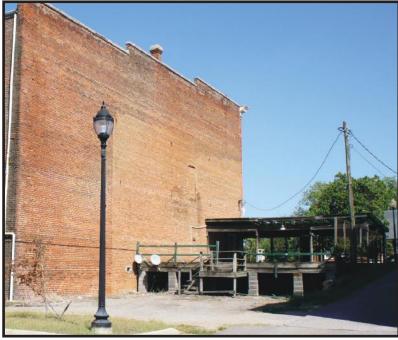
The south elevation is unpainted brick and has a modern glass and metal frame door that provides a direct side entrance from the elevated wooden deck into the building (Fig. 18). The topography slopes

Fig. 18 - South elevation with deck

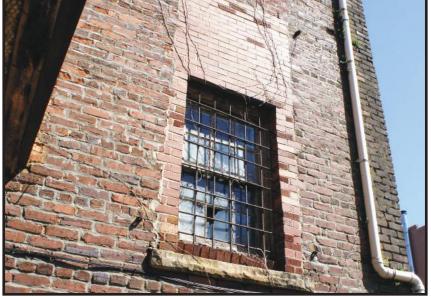
Fig. 23 - Detail of window infill and replacement

The western elevation is in generally poor condition. The brick is in a similar state of deterioration as the south elevation and there have been poor repointing campaigns with large areas of modern brick replacing the historic brick. Mortar repointing has been performed with a mixture of different mortars, noticeably concrete near the basement and 1st level (Fig. 24). Despite these repointing efforts, there is still a significant amount of brick and mortar erosion, especially near the southern downspout, around the hyphen, and along the basement level. All windows that have been infilled with brick were not toothed in (meaning there is a straight line still present from the original opening), making it feasible and desirable to reinstate missing windows (Fig. 25). The three steel pedestrian doors that are extant

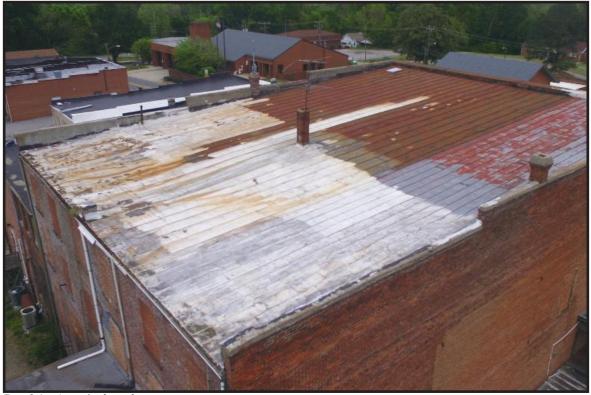
The roof is a low-sloped, shed-style, standing-seam metal roof supported by wood framing. This framing is exposed and visible within the 3rd floor. From aerial photos, it is apparent that multiple campaigns of repair and patches, including at least paint or sealant, have been performed to address deterioration (Fig. 26). Despite these efforts, the roof has fallen into disrepair. Large sections of metal are heavily rusted and have developed cracks. During Hurricane Matthew, the roof of the S&B Building (and S&B Warehouse) was damaged from wind and rain. Coupled with the normal degradation of the roof, this has led to significant damage both to its structure and, by extension, to the building as a whole. Water infiltration is present on every floor; this has degraded numerous materials and areas within the building. Daylight can be seen from below the roof where the rafters sit on the brick, which may be a construction design for ventilation (Fig. 27). However, it is unlikely that the ventilation would

Fig. 26 - Aerial of roof

have originally left this much exposure to the elements, indicating that some sort of covering or soffit may be missing. Also, given the magnitude of water infiltration, it is suspected that the modern gutter system, which is in poor condition, was also installed improperly (perhaps onto the brick instead of the roof, rafters, or missing wood trim at the rafter ends), thus creating a gap which allows water

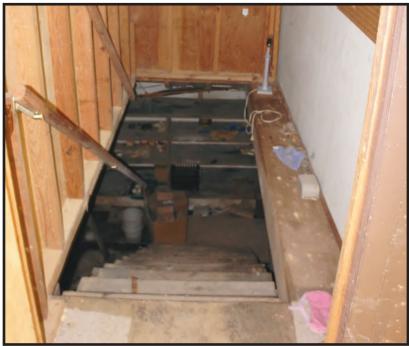
Fig. 28 -1st floor north stair to basement

Two stairs provide access from the basement to the 1st floor. The north-most stair is located near the center of the north wall (Fig. 28). This is a modern untreated wood plank stair with open risers that has been cut through the original flooring with a railing on one side attached to an exposed frame wall on the 1st floor and is not attached further below at basement level. During an initial inspection, an old

boarded-up opening in the middle of the north room floor was noted that cut through the main central beam of the building adjacent to the modern stair, indicating that some sort of circulation access was at one point located there between the basement and 1st floor (Fig. 29). The modern stair is in poor condition. The railing is unsecure and unsafe, and some treads are loose or brittle.

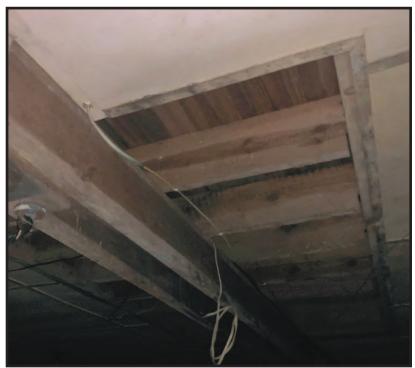
Fig. 29 - Basement infilled stairwell in basement

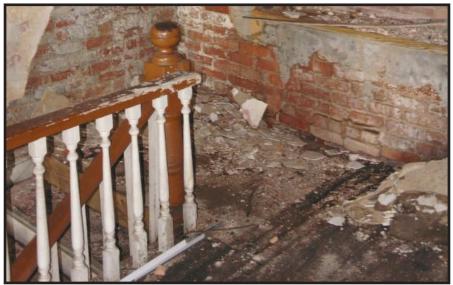
Fig. 31 - 2nd floor southwest corner staircase

and subsequent first step down are in very poor condition due to water infiltration. It is unsafe to walk on a majority of the landing where the wood has become soft from rot. The riser supporting the top tread? has been replaced with a fresh plank of wood that is also starting to deteriorate. Significant repair and restoration are needed in this area, and are related to deterioration noted in the ceiling above (discussed separately in the "Floors and Ceilings" section.)

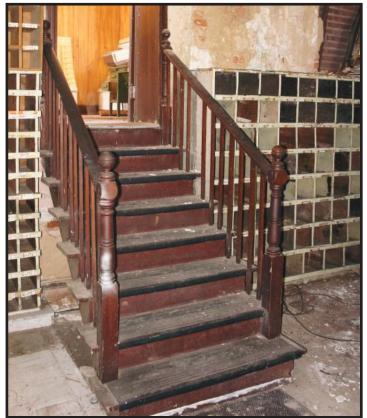
Fig. 32 - 1st floor stair leading to the hyphen room

There is a small modern stair near the center of the west wall on the 1st floor that leads up to the hyphen addition at the rear of the building (Fig. 32). It is an 8-step stair that is comprised of wood risers and treads with a solid wood turned balustrade. Vinyl rubber stair treads cover the wood treads between the railings. The stairs are in fair condition with little damage beyond small scratches and minor chips in the wood.

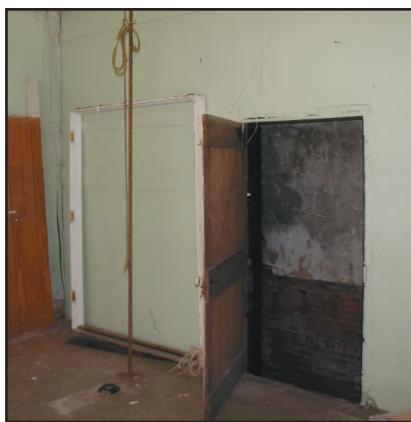
Fig. 33 - 2nd floor stair leading to the 3rd floor

The stairs to the 3rd floor are located at the center of the west wall on the 2nd floor (Fig. 33). They are also untreated wood plank stairs that are exposed underneath and open on both sides. The stairs go up two steps parallel

with the wall until a landing creates a 90-degree turn and the rest of the stairs face east towards the front of the building. There is a simple 2x4 untreated wood railing on the lefthand side of the stairs beginning at the landing. These stairs are in fair to poor condition. Water infiltration along the west wall has compromised the integrity of the wood near the landing and first two steps, but the rest of the steps facing east are sturdy and stable albeit unfinished.

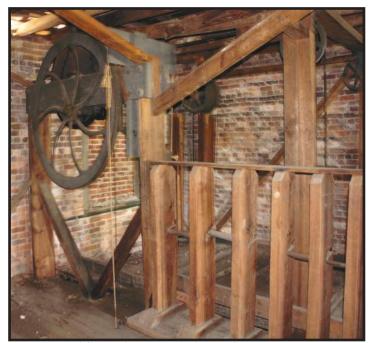
Fig. 34 - 1st floor elevator shaft access (rope pulley system still intact

Cutting through all floors at the northwest corner of the building (near the rear wall) is a large freight elevator shaft (Figs. 34-35). This elevator is a pulley system original to this section of the building (c. 1900 northern addition). The pulley system is still intact with ropes running through the floors near

the shaft for manual operation. A woodplank open elevator car has two pulleys on either side of the elevator at the third floor and connect to the car by metal cable. The rear pulleys are connected to one another on a gear shaft that is connected to a large governor wheel. All pulleys, gears, and wheels are still extant and in good condition. The elevator car appears to be in poor condition, but was not inspected thoroughly on initial site visits for safety concerns.

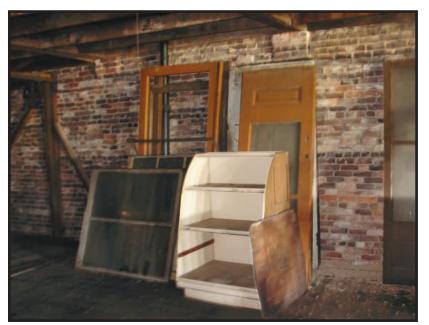
Fig. 36 - 1st floor half-finished walls on northern side

As mentioned in the "Plan" section, the 1st floor is divided into northern and southern sections by a structural wall covered in painted plaster. As such, they will be referred to as "northern side" or "southern side" in the following description. An arched opening is cut into this wall to allow access between the two areas, and the wall terminates roughly three-fourths of the way into the building. The interior sides of the exterior walls are all covered in a thick layer of painted plaster. The painted plaster is peeling at varying rates, but there is little cracking and chipping overall on the 1st floor. In general, modern partition walls on the 1st floor are clad in faux wood paneling on one side and exposed framing on the other or they are made of plywood (Fig. 36). There is a partial wall enclosure surrounding the stairs that extend from the basement to the 2nd floor (described previously). The 2nd floor walls are in poor condition, with missing plaster in some areas and failure is evident near the bottom of the walls. Deterioration is the worst on the rear west wall and especially in the southwest corner where the majority of water infiltration in the building is present. The 3rd floor walls are exposed brick with some mortar deterioration and water infiltration (Fig. 37). There are two temporary plywood rooms along the west wall.

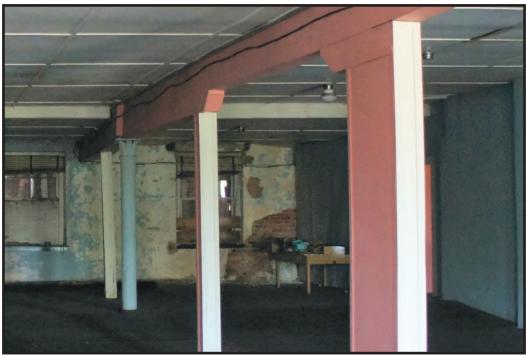
Fig. 39 - 2nd floor mixture of column sizes and shapes

square and rectangular wood with thin cap on the corners. There is one cast-iron Corinthian column in line with the wood columns. Because it rests on a rectangular base-plate and cuts into the ceiling beam, it is likely that this is a replacement or additional beam inserted at a later date (Fig. 39). Some of the columns are directly attached to wood joists, while

others have a functional rectangular capital between the column and the joist. These 2nd floor columns all appear to be in fair condition. The 3rd floor columns are a mixture of square and rectangular unpainted solid-wood columns supporting the exposed joist ceiling. The central rectangular columns have a rectangular capital similar to those present on the 2nd floor between the column and joists. The columns are in fair condition with some natural splitting evident. The structural report in the PER discusses the columns' conditions and further detail can be found there.

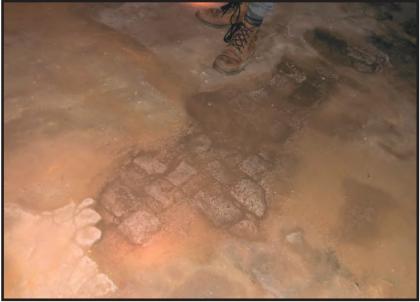
Fig. 40 - Basement concrete floor with pavers underneath

The basement has an unfinished concrete floor and an exposed wood frame ceiling. The floor has worn away in some places to reveal a brick-paved floor on the south side of the building (Fig. 40). It is unknown if this floor runs throughout the basement under the concrete. The northfront half of the building is two

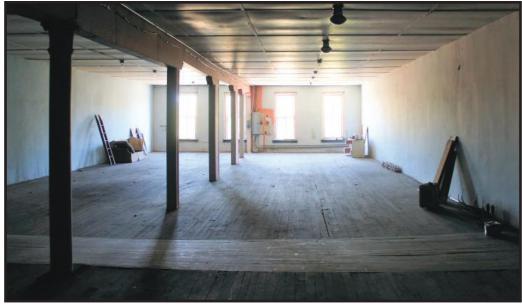
Fig. 43 - 2nd floor southern room showing ramp and ceiling batten strips

but approximately two feet lower. Due to the dropped ceiling, the tin tiles could not be fully evaluated, but they appear to vary in condition. A significant amount of the tile that is visible is rusted and damaged to the point of disintegration, while other areas appear to be in relatively good condition. The 2nd floor retains historic dark stained wood plank floors. There is a sloped area of the floor in the south room; its wood plank flooring running perpendicular to the majority of the wood floors (Fig. 43). The 2nd floor ceiling is finished with modern painted plywood with a grid of 2x1 wood batten strips running across the ceiling. In general, the floor is in stable condition with the exception of the deteriorated area in the southwest corner of the building. The small room in the rear of the northside has an untreated wood plank floor that is in varying condition. The plywood ceiling is in fair to

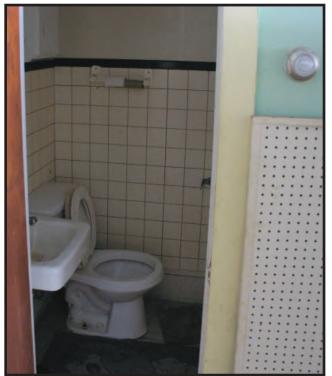
Fig. 46 - 1st floor restroom along north wall

There is minimal plumbing in the building and is centralized to the north wall. There is a restroom on both the basement and 1st floor with a sink and toilet fixture in each (Fig. 46). The toilet in the basement is missing, but the drain pipe is still

located in the floor. At the time of of this report, initial inspection of the plumbing system noted that there were issues with the septic and water lines that will need to be addressed during any rehabilitation efforts.

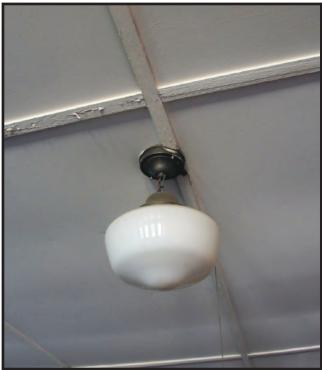
Fig. 47 - 2nd floor lighting fixtures

floor (Fig. 47). The electricity was not turned on during initial inspections, and further examination by a qualified electrician is necessary to assess the electrical wiring and circuits.

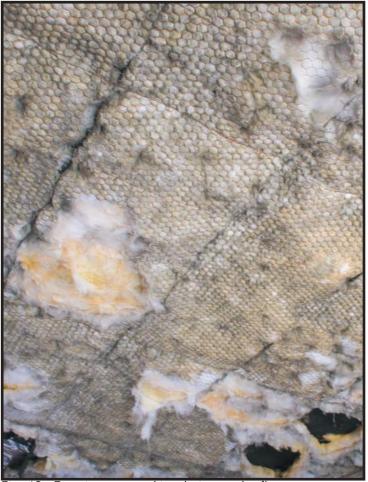
Fig. 48 - Exterior exposed insulation under floor structure

Situated half-way between the 1st and 2nd floor of the main building is a modern 6-course common bond brick hyphen with steel I-beam floor support connecting the main building to the S&B Warehouse. There is exposed insulation on the underside of the floor structure, between the I-beams (Fig. 48). It is secured to

the hyphen by chicken wire. The hyphen has paired one-over-one double hung wood sash windows

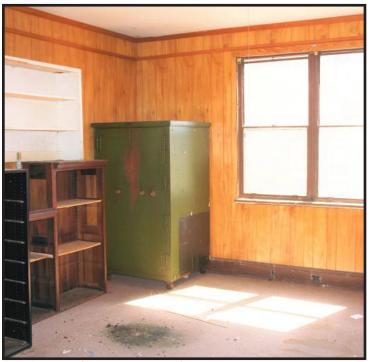
Fig. 49 - Hyphen interior southeast corner

on both the north and south sides. On the interior, the hyphen is accessible from the main S&B Building by a set of stairs leading down to the 1st floor. However, the hyphen does not provide interior access to the rear storage building and there is no discernable evidence that it ever did. The interior walls of the hyphen are wood paneled, the floor is covered in commercial-grade carpet, and the ceiling is painted plywood with a fluorescent light in the center (Fig. 49). The hyphen is in fair to poor condition. The insulation underneath the floor structure is starting to deteriorate and the chicken wire holding it has failed in places. The I-beams appear to be structurally sound and in good condition, although there is rust evident which must be abated to prevent further damage. The brick exhibits the same type of deterioration as that documented at the S&B Building, including limited areas of missing mortar. Some of the window panes have been broken, but the sills appear to be in fair condition. The interior finishes have some water damage and general wear and tear.

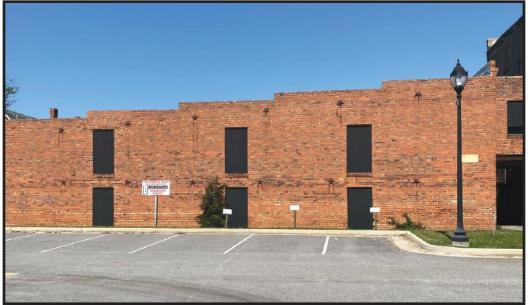
Fig. 50 - S&B Warehouse south elevation - windows currently boarded for protection

Both the north and south elevations of the S&B Warehouse have six metal-frame windows (three on the 1st floor and three directly above them on the 2nd floor) with a 4-wide by 5-high pane configuration (Fig. 52). The windows are currently boarded up to help protect against vandalism (Fig. 50). The center windows panes (2x3) are on a pivot and can swing open, with the surrounding panes remaining stationary. Inside, all window openings have been infilled three-quarters of the way up with cement blocks. Along the 2nd floor line and near the roof, star-shaped anchor plates dot both

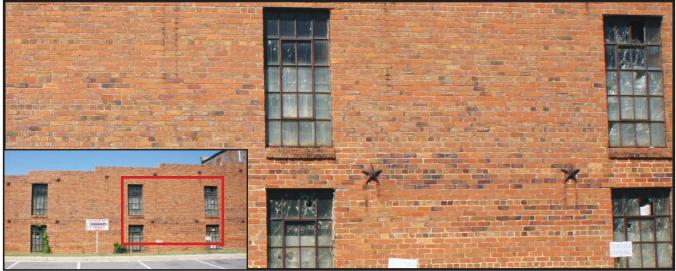
Fig. 52 - S&B Warehouse window details and star anchor plates

and bridge connect to the building. Biological and vegetative growth is also present, most drastically along the north elevation. Rust stains are evident below each anchor plate. A small portion of the bottom west wall has completely failed and the bricks are laying in a pile on the ground, creating a hole in the elevation (Fig. 53). Above this hole is the most significant mortar deterioration of the building. From

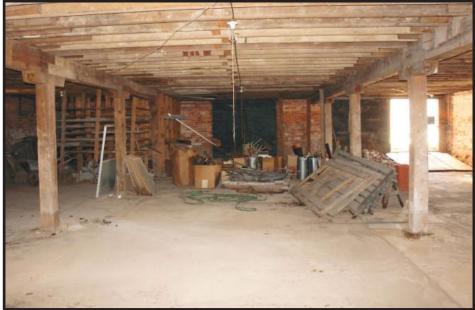
Fig. 54 - S&B Warehouse 1st floor looking east

The 1st floor is an open floorplan with exposed exterior brick walls and a post and beam structural system comprised of two rows of wooden posts running the length of the building and dividing the interior into three bays (Fig. 54). The floor is concrete and walls are exposed brick. Along the north wall is an open wood plank staircase leading to the 2nd floor. This is also an open room with exposed

exterior brick walls and a structural post and beam system comprised of two rows of wooden posts running the length of the building. The 1st floor is in fair condition. There is some mortar and brick deterioration. Along the south wall, some bricks have lost their top layer and have begun to crumble. There is efflorescence and biological growth along the bottom, but it is minimal; otherwise, the brick is sound. Vegetative growth is extant through the broken window panes, but it does not appear to be damaging the brick yet. There is little deterioration to the post and beam structure, but there is a temporary structural shoring that indicates some extent of structural failure. This is explained further in the Preliminary Engineering Report (PER) in Appendix A. The 2nd floor exterior brick walls are

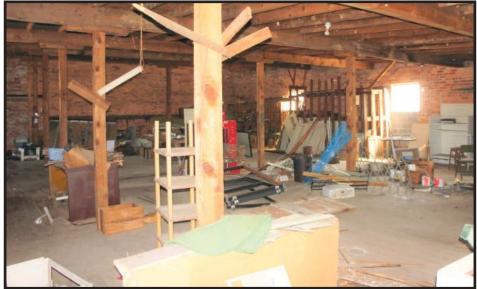
Fig. 55 - S&B Warehouse 2nd floor looking southeast

in good condition with little mortar and brick deterioration (Fig. 55). There is some water-damaged flooring in certain areas while in other areas, floorboards are missing completely (Fig. 56). The majority of floorboards are not tightly joined so that the 1st floor is visible through the floorboards on the 2nd floor. The structural wood posts are mostly in good condition with some nail holes and pieces of wood seemingly arbitrarily attached to the posts. There is deterioration of some floor and ceiling joists due to water infiltration and biological growth. As the PER details, the northwest corner of the building has the worst water infiltration issues and structural damage.

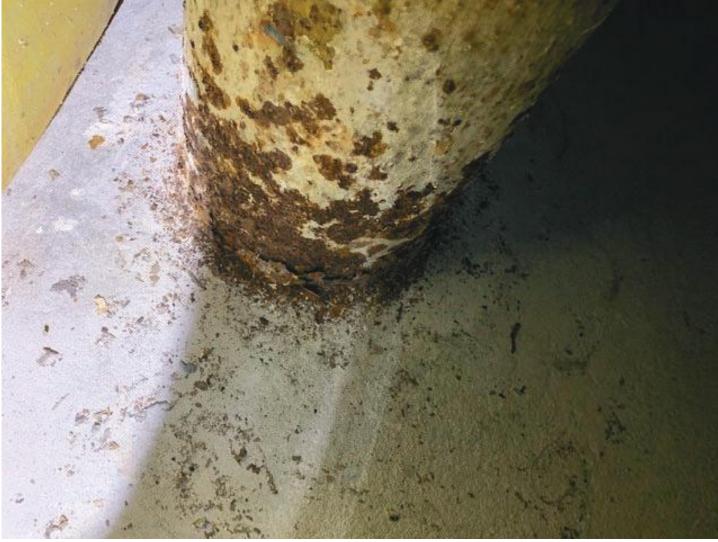
PHOTOGRAPH #17 S&B BUILDING -RUSTED AND PITTED BASE OF STEEL COLUMN IN THE BASEMENT

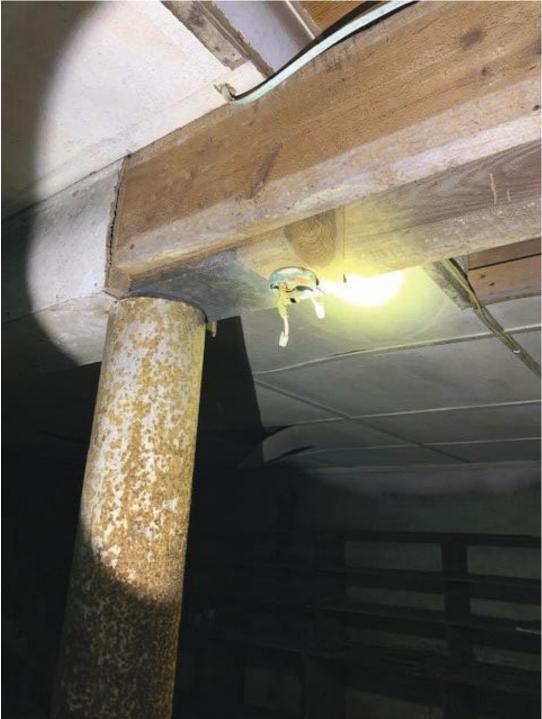
PHOTOGRAPH #19 S&B BUILDING – ONE END OF WOOD GIRDER THAT WAS CUT

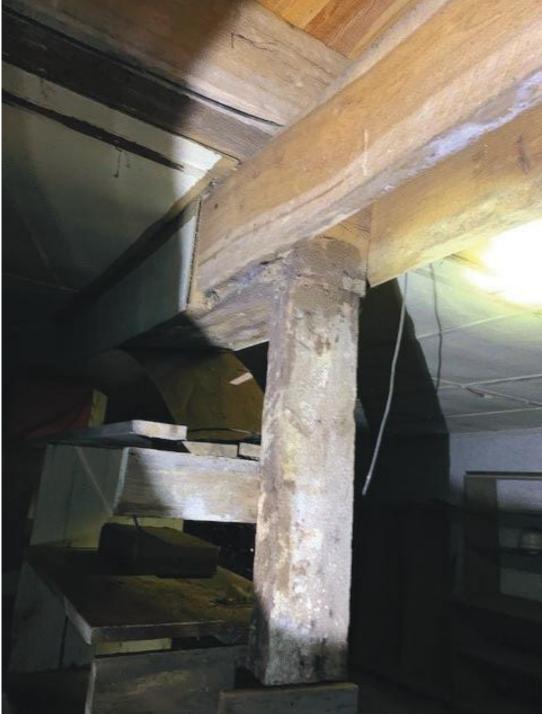
PHOTOGRAPH #22 S&B BUILDING -DOUBLE 6"x6" COLUMNS IN MIDDLE WITH 8"x8" TO THE LEFT

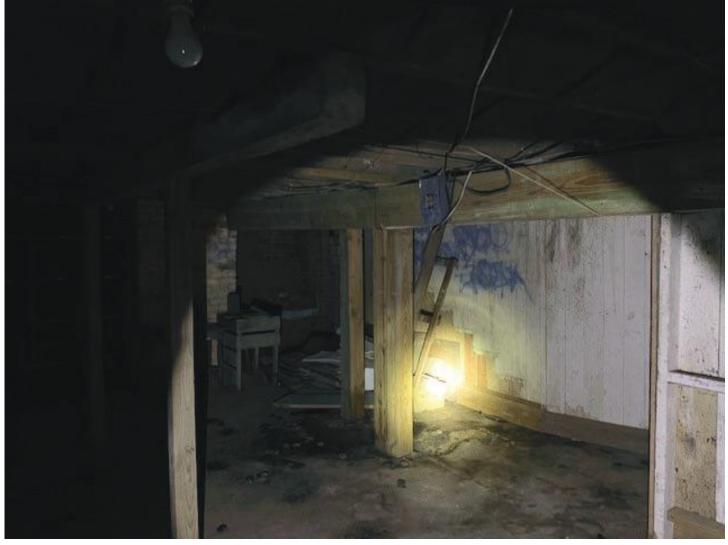
PHOTOGRAPH #23 S&B BUILDING -ADDED 6" x 6" WOOD COLUMN

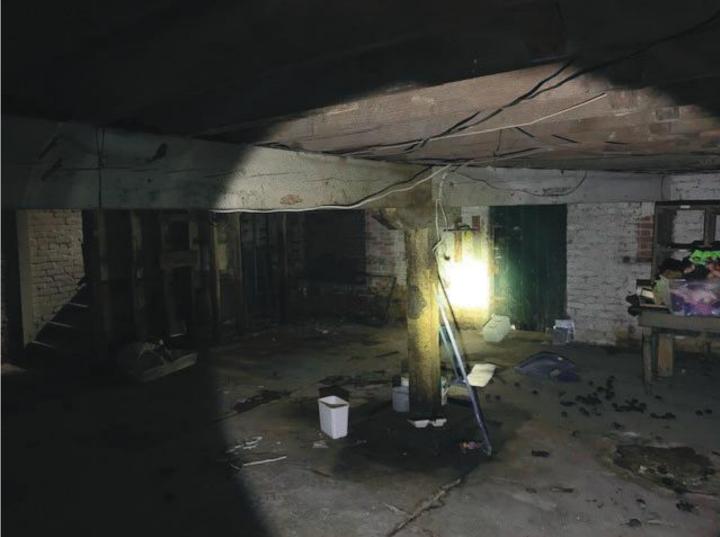
At the east end of the girder line, there is an 8"x8" wood column that can be seen in Photograph #26. Temporary shoring consisting of a 4"x8" wood beam and two 4"x4" wood columns have been added towards the rear of the building that can be seen in Photograph #27. A typical 8" steel column bearing on brick condition can be seen in Photograph #28. Again, the heavily infested 8"x12" wood beam can be seen in Photograph #29. Termite infestation and brick nogging can be seen in Photograph #30.

PHOTOGRAPH #27 S&B BUILDING -TEMPORARY SHORING

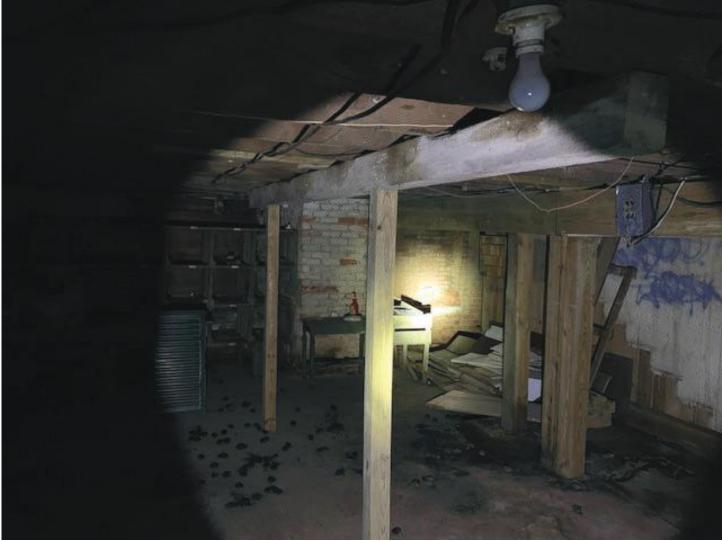
PHOTOGRAPH #28 S&B BUILDING -TYPICAL STEEL COLUMN TO BRICK PIER CONNECTION

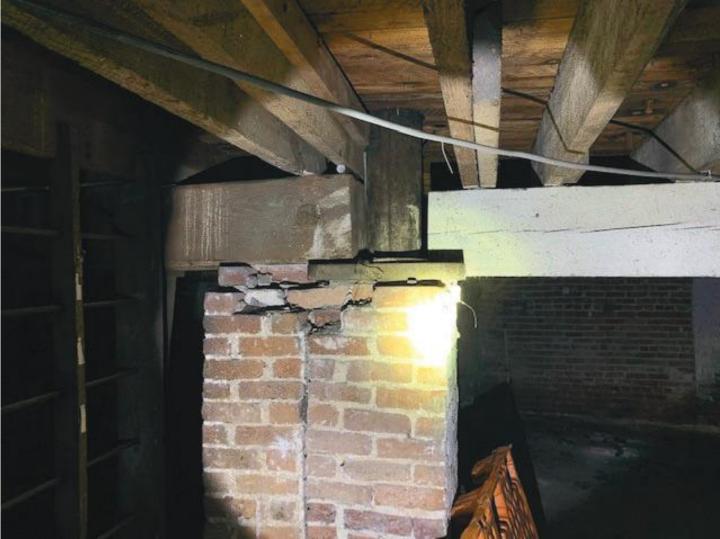
PHOTOGRAPH #29 S&B BUILDING -HEAVILY TERMITE INFESTED GIRDER

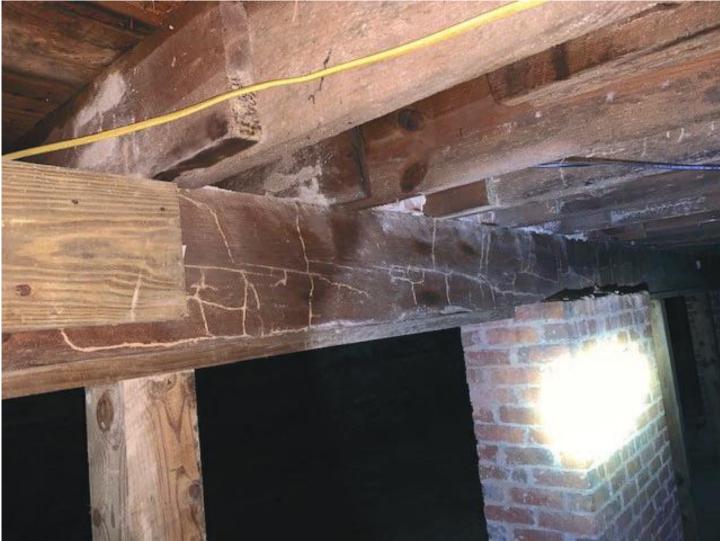
PHOTOGRAPH #30 S&B BUILDING -GIRDER WITH TERMITE TRAILS AND BRICK NOGGING

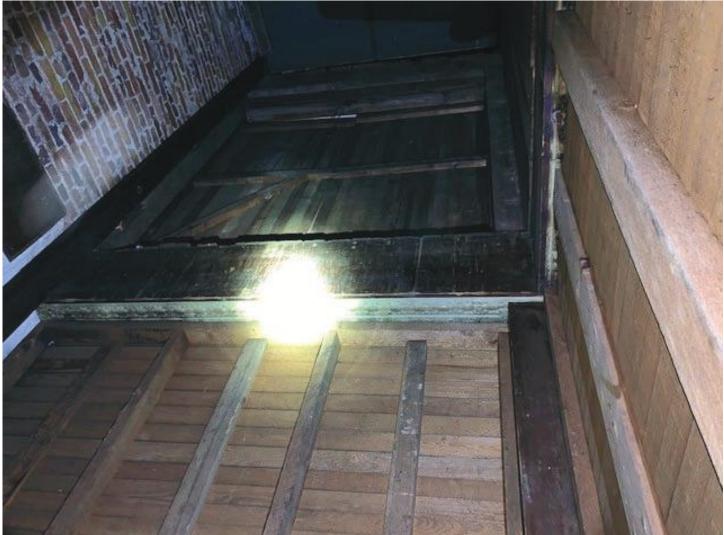
PHOTOGRAPH #33 S&B BUILDING -ELEVATOR SHAFT

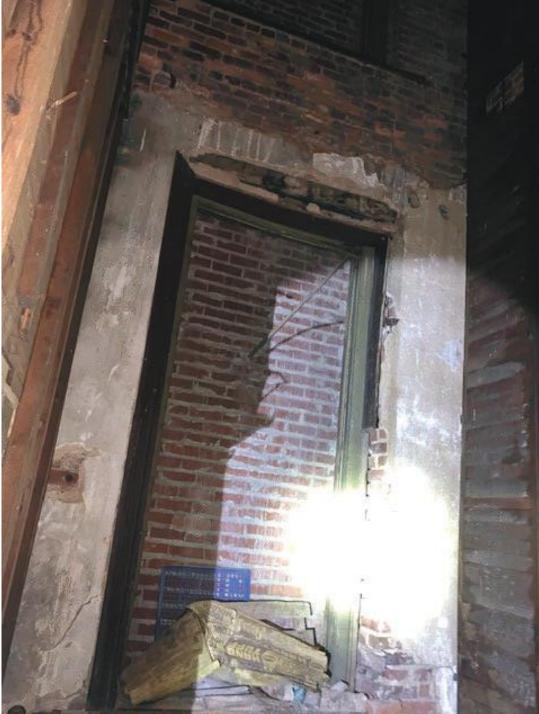
PHOTOGRAPH #34 S&B BUILDING -BOTTOM OF ELEVATOR SHAFT

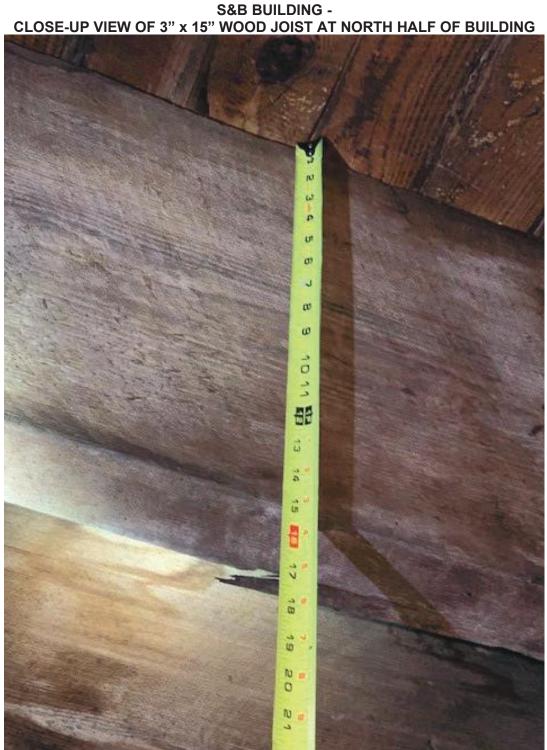
- 1. There is an area in the southwest corner that has excessive damage due to water infiltration. The area is about 17' x 8' and includes four (4) rotted 3"x12" joists and decking above. This deteriorated corner can be seen in Photograph #44.
- 2. Two (2) of the six (6) headers over windows and doors are badly deteriorated on the rear of the building.

PHOTOGRAPH #44 S&B BUILDING -DETERIORATED FLOOR AREA

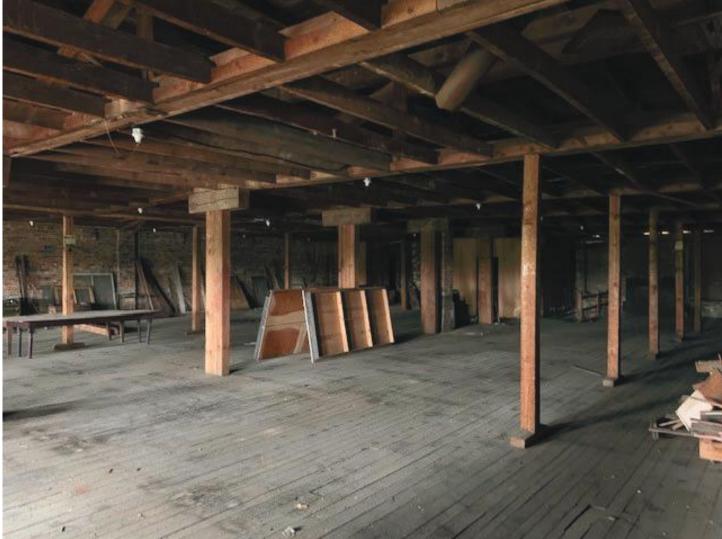
Roof: The roof structure consists of heavy timber roof trusses spanning in the north-south direction spaced at approximately 15' on center. They span from exterior walls to the middle 8"x15" wood columns that occur over columns below. In most cases, there are also some additional 6"x6" columns at midspan of the trusses. The ceiling joists at the roof are 2"x6" spaced at 24" on center spanning east-west between trusses. The roof rafters are also 2"x6" spaced at 24" on center spanning east-west. The 8"x8" main columns and 6"x6" columns along with typical ceiling framing can be seen in Photograph #45. The roof trusses and column capitals can be seen in Photograph #46. Some of the deficiencies we found in the roof structure include:

PHOTOGRAPH #46 S&B BUILDING -ROOF STRUCTURE

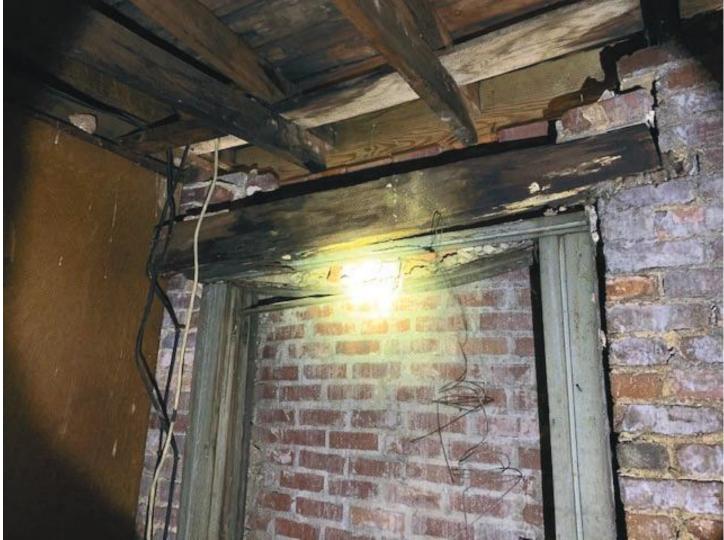
- 1. Several ceiling joists and rafters are rotted badly, as well as the roof deck in the southwest corner over deteriorated areas below. This deterioration can be seen Photograph #47.
- 2. Two (2) of the headers over windows at the rear of the building are badly deteriorated. One of the headers can be seen in Photograph #48.
- 3. The bottom chord at one (1) of the main roof trusses is deteriorated and needs repair. This is the first truss at the front of the building and the deteriorated bottom chord can be seen in Photograph #49.
- 4. A dozen of the ceiling joists are rotted at the ends at the front of the building.

PHOTOGRAPH #49 S&B BUILDING -BOTTOM CHORD OF FIRST MAIN TRUSS AT FRONT OF BUILDING

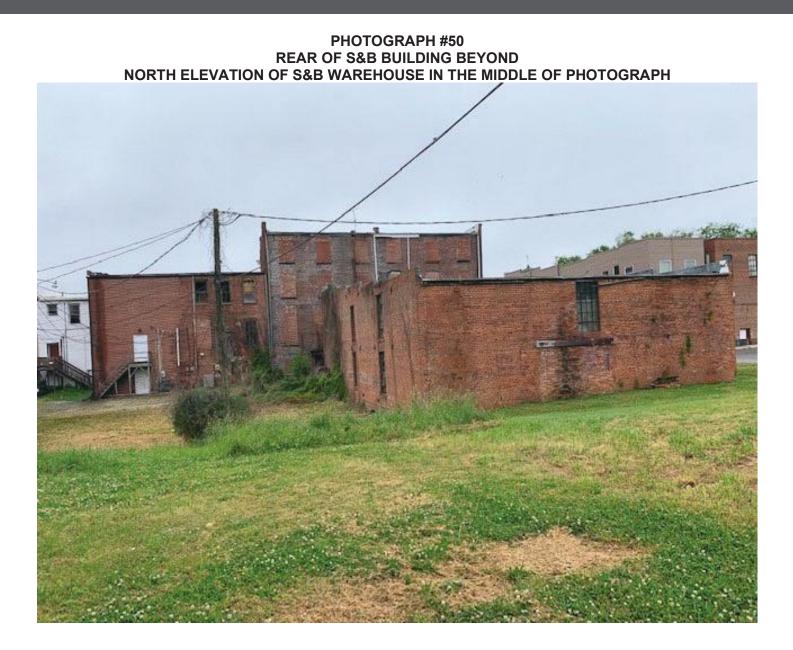
This building is constructed with a full basement and one (1) story above and is a brick and wood structure. The exterior of the S&B Warehouse can be seen in Photographs #50, #51, and #52. Although I could not access the roof of the S&B Warehouse, I could see the roof from a distance (Photograph #51). From this Photograph, I can see the roof is in poor condition. Since the roofing wraps over the parapet, it is difficult to determine the condition of the parapets; however, there are plenty of breeches in the roof where it turns up the parapet walls. I would guess from this that the parapets will need some repairs when the roofing is replaced. Another area of concern that applies to the roof is where the rear wall of the S&B Warehouse meets the roof. The top of the rear brick wall and the roof structure has no closure as can be seen in Photograph #53. The brick will need to be repaired and a frieze board will need to be installed correctly. Some other exterior deficiencies are as follows:

PHOTOGRAPH #51 REAR OF S&B WAREHOUSE (WEST ELEVATION)

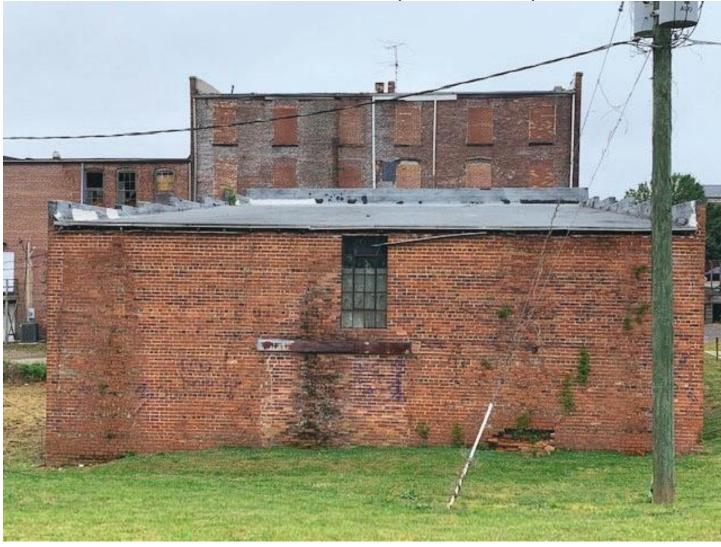
PHOTOGRAPH #52 SOUTH SIDE OF S&B WAREHOUSE ON RIGHT

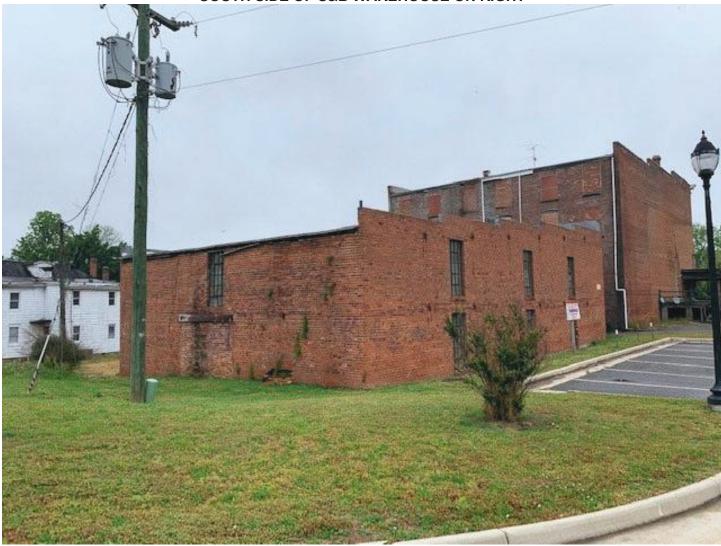
PHOTOGRAPH #53 REAR OF S&B WAREHOUSE AT WALL TO ROOF JUNCTURE

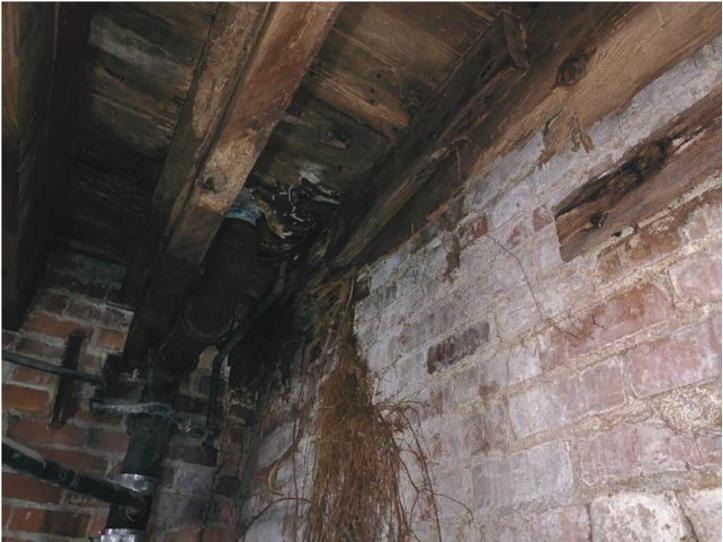
- 1. The east end of the 8"x12" girders at the two girder lines are badly deteriorated. One is no longer bearing on the exterior wall as originally built, as seen in Photograph #59. The other has crushed and dropped about 6", as can be seen in Photograph #60. Temporary shoring has been installed to avoid collapse of the girders. The temporary shoring needs to be more substantial.
- 2. About fourteen (14) first-floor joists in the northwest corner are rotted badly, including the deck in an area of about 15'x20'. Some of the damage can be seen in Photographs #61 and #62.
- 3. The first-floor joist on the west side is rotted badly.

PHOTOGRAPH #61 S&B WAREHOUSE – DETERIORATED FRAMING IN NORTHWEST CORNER OF ROOF

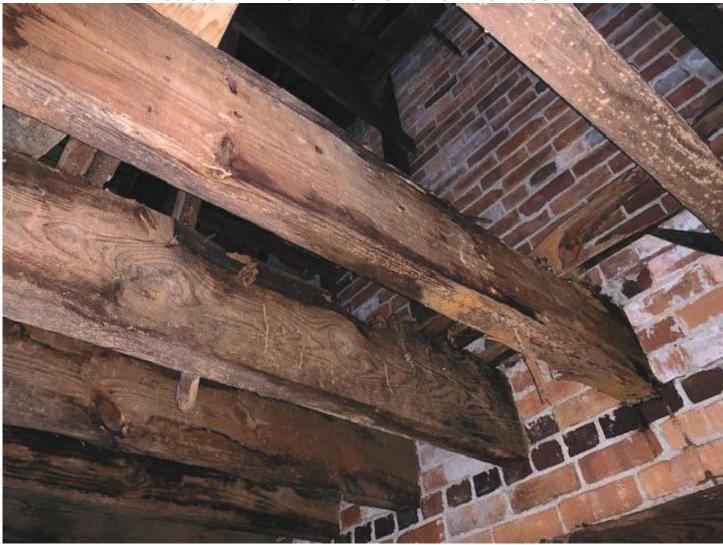
PHOTOGRAPH #62 S&B WAREHOUSE -JOISTS IN THE NORTHWEST CORNER OF FIRST FLOOR
